IMPORTANT SERVICE BULLETIN

Avid Ball-Bearing Disc Brake

Improper Setup Process

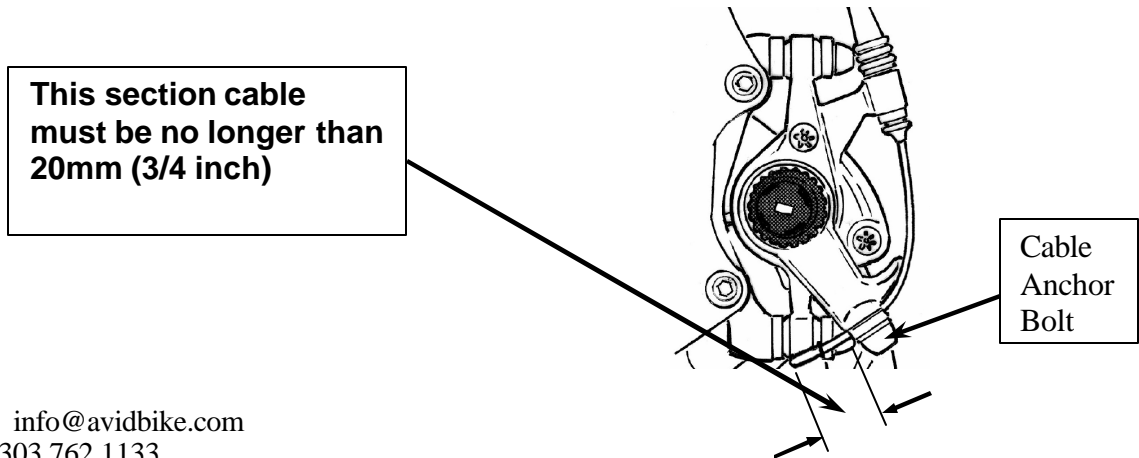
Cable disc brakes have been installed with an excess of cable extending past the cable anchor bolt.

This excess cable could get caught in the rotor and be pulled into the caliper, causing the wheel to lock up, possibly resulting in serious injury to the rider.

During setup and final adjustment it is crucial that there is no more than 20mm (3/4 inch) of excess cable left beyond the anchor bolt of the brake. (See **Diagram**)

As a precautionary measure, if the improper setup process has been a practice in your shop, you must contact your end-user consumers immediately and have these bikes returned to your shop so the brakes can be inspected and have any excess cable removed.
