cannondale

OWNER'S MANUAL SUPPLEMENT

2010 SCALPEL

Magnesium Shock Link

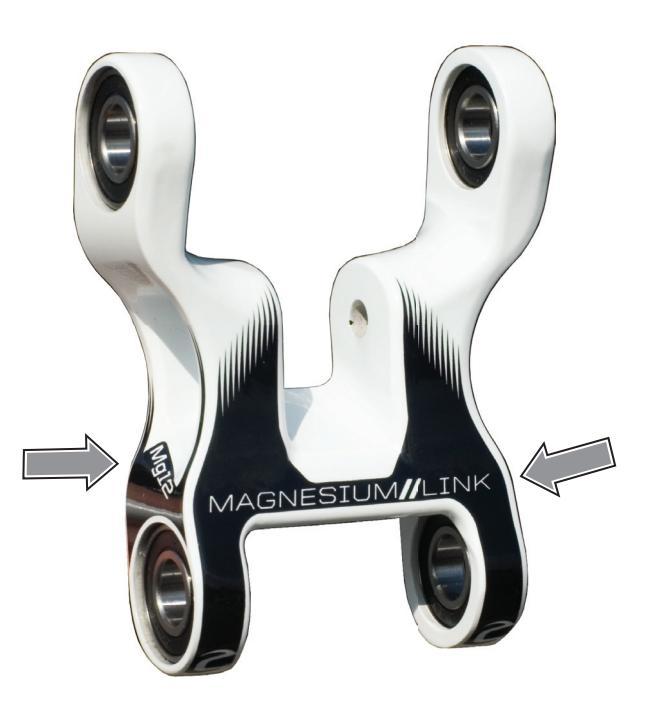
Certain 2010 model Scalpels are assembled using a high-performance forged magnesium shock link. Magnesium links can be identified by the special graphic markings. "MAGNESIUM // LINK" and "Mg 12." See photo at right.

During manufacture, magnesium Scalpel links are coated in special process. The process covers or coats the raw part with Keronite, a barrier material. This coating underlies the paint and clear coating. The three coatings act to isolate the magnesium part and prevent contact with the dissimilar metals such as the bearings and the shock bolt.
